Lessons Learned from SRS Salt Processing Scale-Up: Filtration and Solvent Extraction

Michael Poirier

WSRC-STI-2007-00683, Rev. 1

December 4, 2007

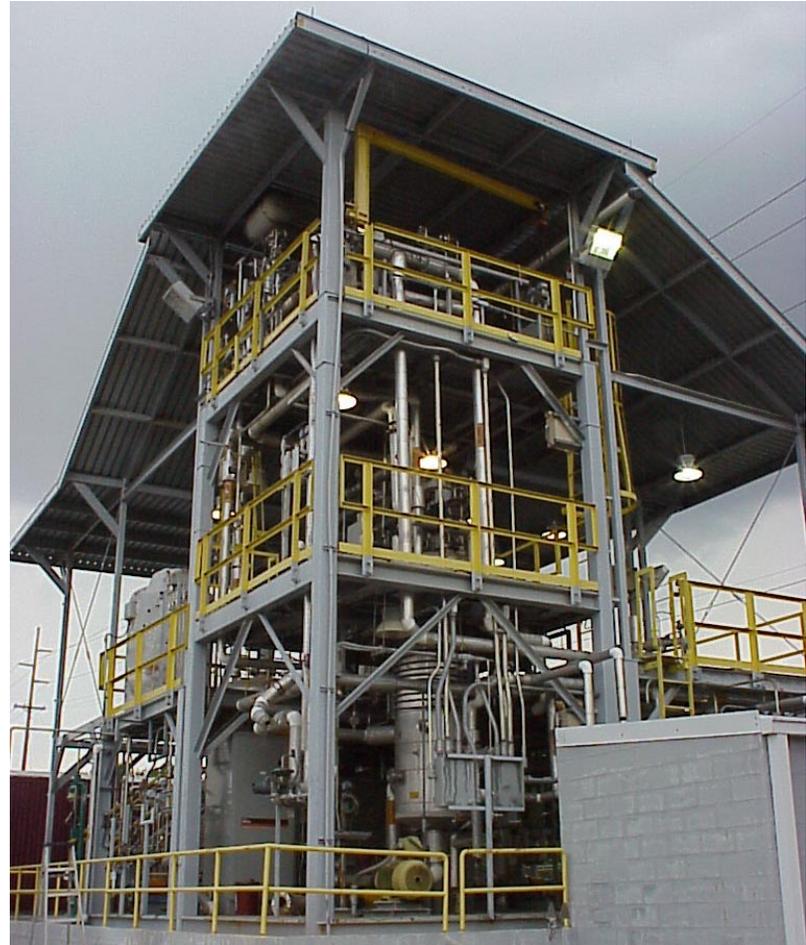
- **Constructed pilot-scale filtration unit at the University of South Carolina in 1994-1995**
 - DOE grant to USC
 - Commercial construction firm with USC oversight
 - Full-scale filter tubes
 - 0.625 in ID
 - 10 ft length
 - 7 tubes versus 144 in facility
 - 150 – 500 gallon feed
 - 225 gpm feed pump

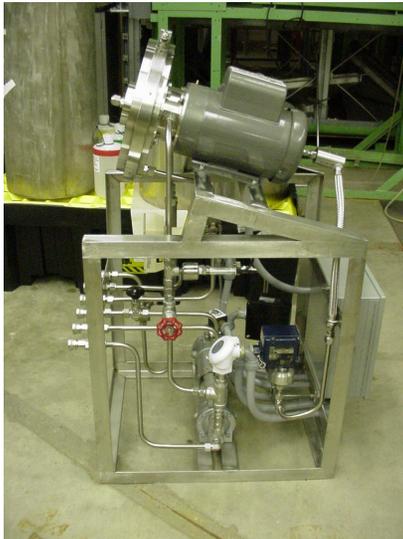
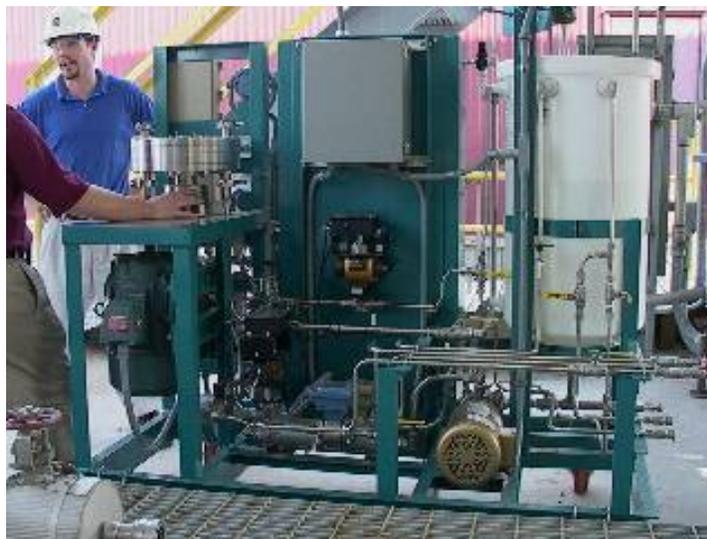
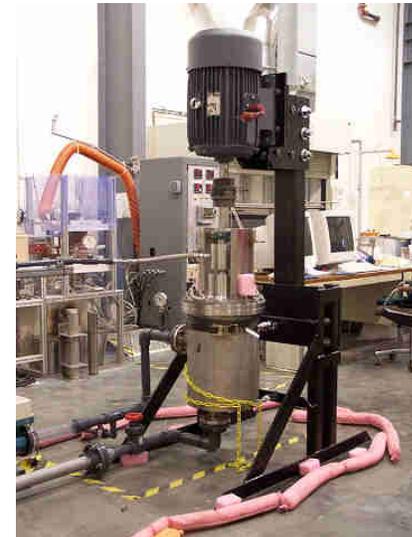
- 1 – disk commercial unit for feasibility testing at vendor
- 1 – disk commercial unit for actual waste testing at SRS
- 3 – disk commercial unit for pilot-scale reliability testing at USC
- 25 – disk prototype unit (full-scale) for demonstration of enhanced design
